Docket No. 217 – Development and Management Plan Inspection

Northeast Utilities Service Company Certificate of Environmental Compatibility and Public Need for the construction of a 345-kV electric transmission line and reconstruction of an existing 115-kV electric transmission line between Connecticut Light and Power Company's Plumtree Substation in Bethel, through the towns of Redding, Weston, and Wilton, and to the Norwalk Substation in Norwalk, Connecticut.

Date: February 16, 2006

Location: Overhead Line (Composite 345kV and 115kV Gallows Hill to Archers Lane) and (345kV H-Frame Hoyts Hill to Gallows Hill)

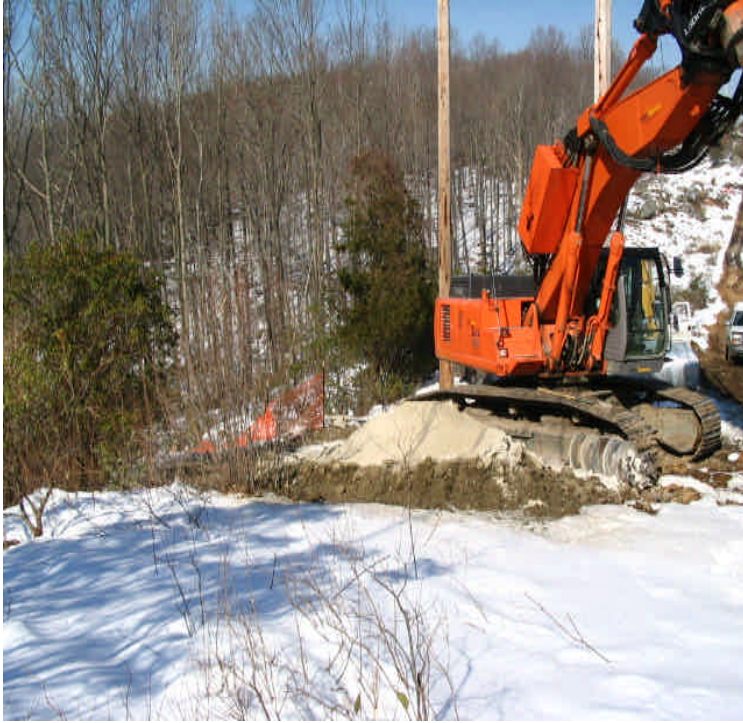
Photo on the left shows where a second mat should be installed near the stream crossing at pole #19 to increase stability. Photo on the right shows the erosion control installed along the access road in the same area. 2/16/06

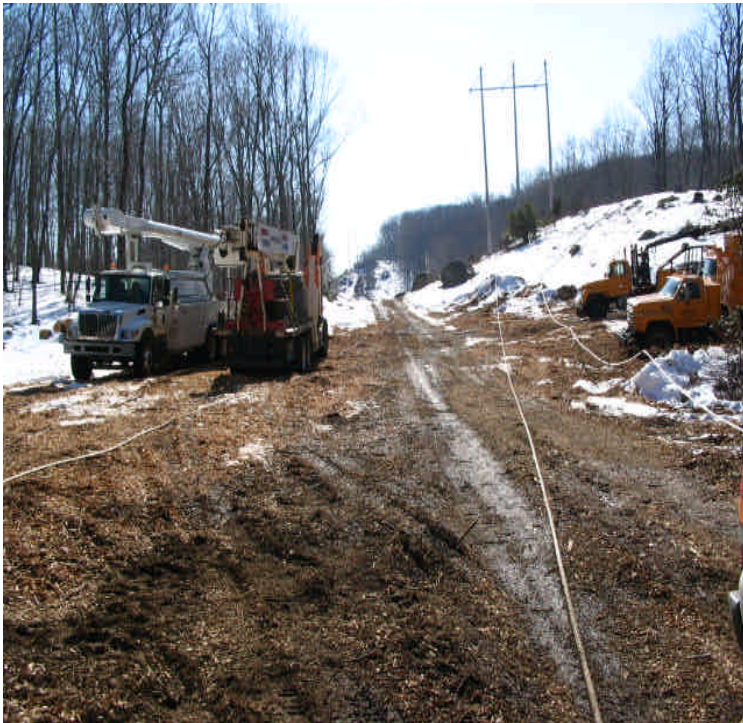
Photo on the left shows excavation occurring at a pole location along the Bethel Reservoir section. Photo on the right shows the wetland crossing between poles #17 and 18. Chips placed in the access road here have helped the tracking situation but silt fence should be installed at the approach. 2/16/06

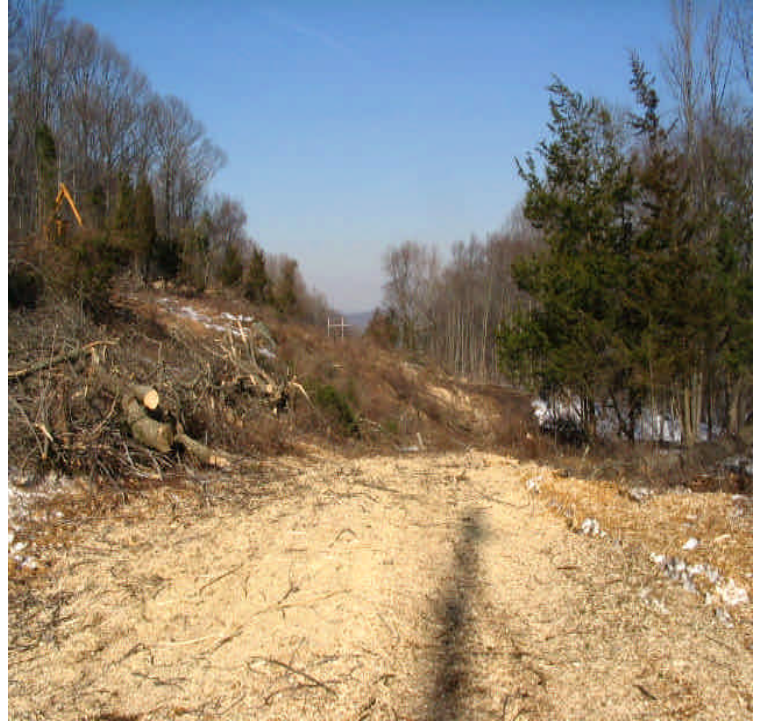
Photo on the left shows the excavation and silt fence near pole #6. snow may have impacted the silt fence. Check to see if it needs repairs and remove sediment when feasible. Photo on the right shows the clearing and chipping near pole #5. 2/16/06
